**Phase II Soil and Groundwater Quality Investigation
General Mills Facility
Vallejo, California**

February 7, 2007

Northgate Environmental Management, Inc.
300 Frank H. Ogawa Plaza, Suite 510
Oakland, California 94612

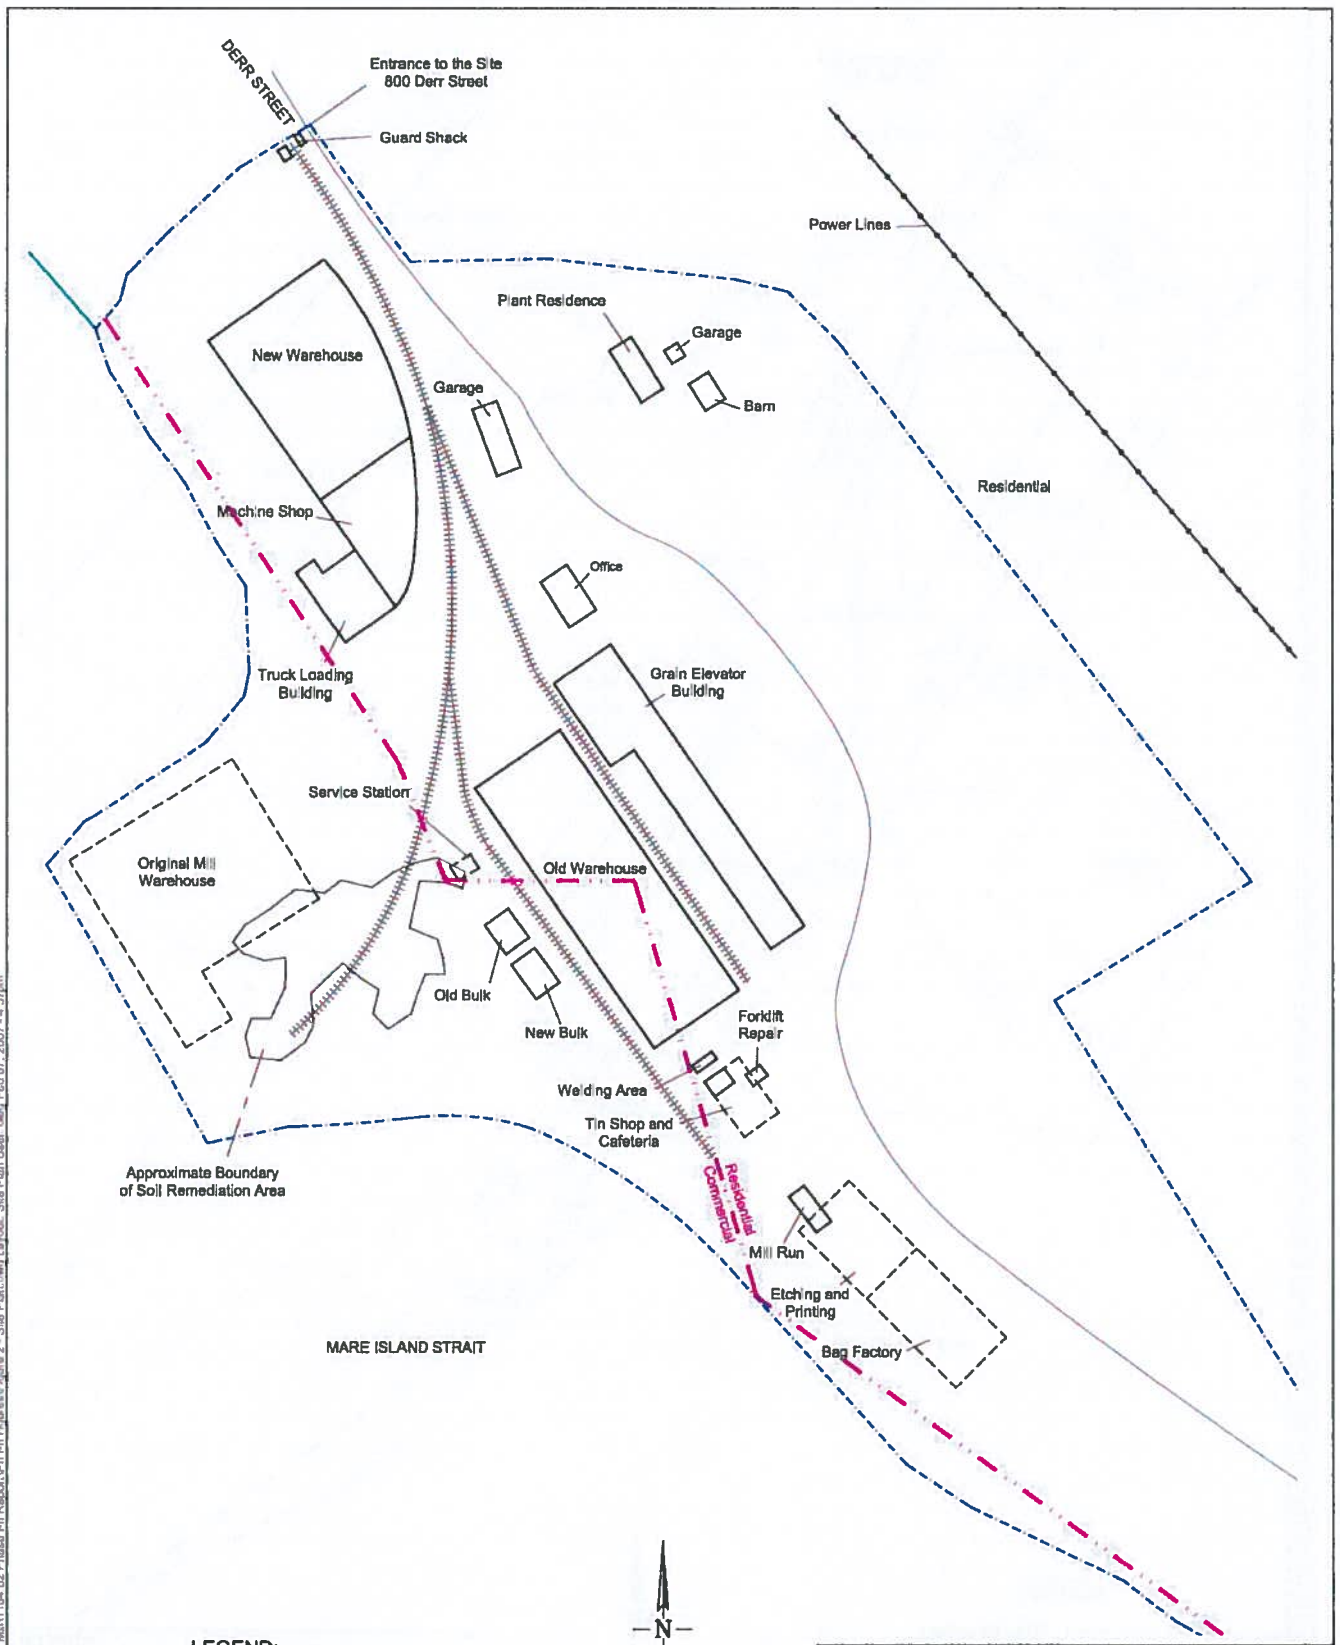
FIGURE 2
Site Plan

This report presents the results of a Phase II Soil and Groundwater Quality Investigation performed by Northgate Environmental Management, Inc. (Northgate) at the General Mills property, located at 800 and 790 Derr Street in Vallejo, California (Site). The Site consists of approximately 39 acres of land developed with a flour mill and associated structures. A Site Location Map is shown on Figure 1 and a Site Plan is shown on Figure 2.
